Navajo Abandoned Uranium Mine

Site Screen Report

Chimney No. 1 AUM Site

Navajo AUM Northern Region

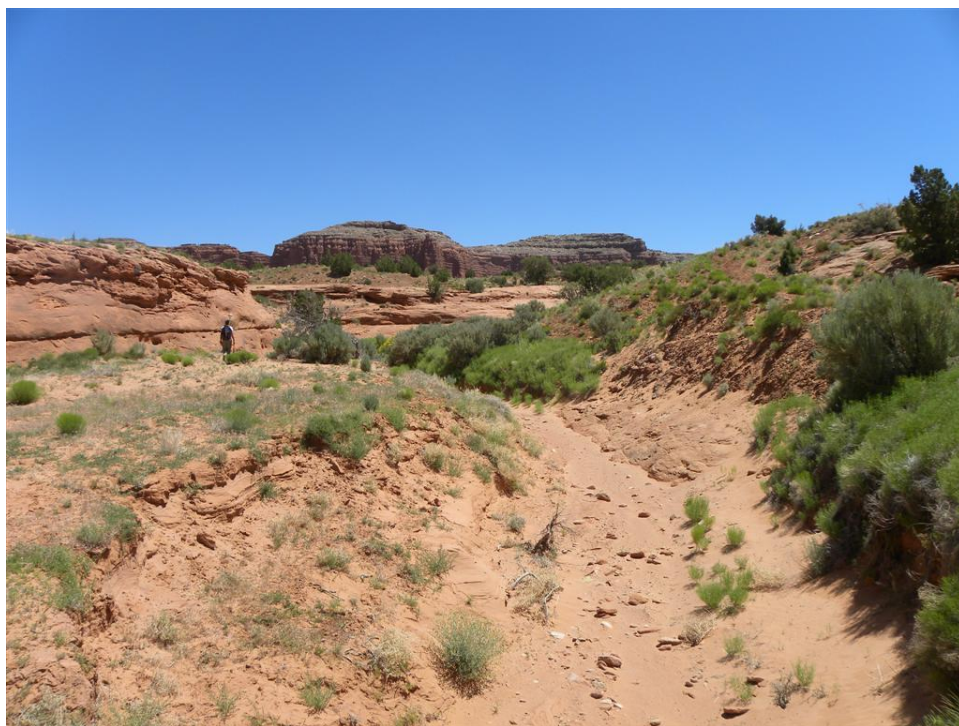
Photo 4. Drainage W of Chimney No. 1 site
